CAVITATION EROSION OF WET-SLEEVE LINERS: CASE STUDY

ABSTRACT

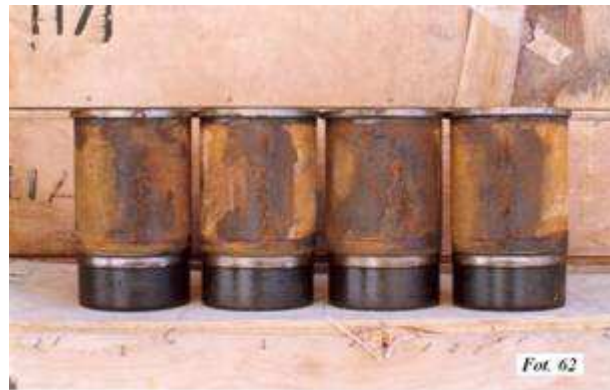
Corrosion and cavitation wear in wet-sleeve liners is shown in Figure 3. This approach was tested on four-cycle diesel engines, with 4 cylinders of bore x stroke = 105 x 115,5 mm, in the cooling system of which distilled water had been used. Figure 3 shows the liners after 1000 working hours subjected to the vibratory cavitation environment of diesel engine. The wear is evident and in advanced stage to all the cylinder liners. The corrosion erosion had little effect on forming the honeycombed structure of the eroded surface. Corrosion appears on the liner wall due to electrochemical action and causes damage but the rate normally decreases as an oxide layer is formed. When cavitation erosion also occurs, the protective oxide layer is removed by bubble collapse. The deeply pitted appearance of the eroded surface is characteristic of the cavitation erosion. The location of the pits is coming from the bottom to the middle of the liners on the thrust side. In the antithrust side of the liners cavitation eroded surface is not formed.

Figure 3: Corrosion and cavitation erosion in wet-sleeve liners was observed after 1000 working hours. It is about a turbocharged engine with 4 cylinders of bore x stroke = 105 x 115,5 mm, in the cooling system of which anticorrosion and anticavitation inhibitors had not been used.

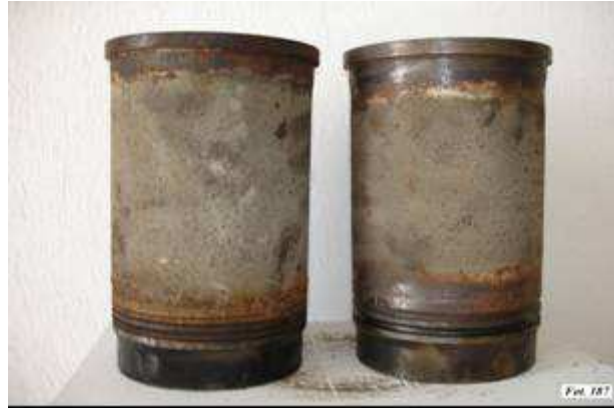
Construction changes such as thickening the liner wall and coatings seem the only effective way in reducing cavitation erosion. Figure 5 shows wet-sleeve liners that were not damaged by cavitation erosion after 5600 h operation. This approach was tested on four-cycle diesel engines with 4 and 6 cylinders of bore x stroke = 110 x 120 mm. The thickness of the liner wall is 8,3 mm versus 5,3 mm of the above mentioned cases. The cooling system of this diesel engine was not properly maintained. Muddy deposit appears on the liners wall.

Figure 5: Wet-sleeve liners were not damaged by cavitation erosion after 5600 h operation. This approach was tested on a turbocharged engine with 6 cylinders of bore x stroke = 110 x 120 mm. The thickness of the liner wall was 8,3 mm, and the cooling system is not properly maintained.

A variety of strategies had been used to control cavitation erosion on wet-sleeve liners. Cooling additives that incorporate anticorrosion and anticavitation inhibitors were used to reduce the cavitation process to an acceptable rate. From the above, it appears that the proper cooling system maintenance using the right antifreeze and keeping up proper levels of recommended additives is essential to keep the surface corrosion under control, but it can't be a major force in preventing liners pitting. The aspects of "a good radiator pressure cap help keeping ambient pressures above the vapour pressure of the coolant, thereby, reducing the amount of cavitation" or "the thermostat keeps the temperature of the coolant at a level that reduces the energy level of the bubble collapse" they were not confirmed by our experiments in the field conditions.
